**Flood Control Project Maintenance  
Levee Inspections****LMA District Cover Sheet****Spring 2016 Levee Inspection Results****Reclamation District No. 0150 Merrit Island**

**Spring 2016 Levee Inspection Results**

**Reclamation District No. 0150 Merrit Island**

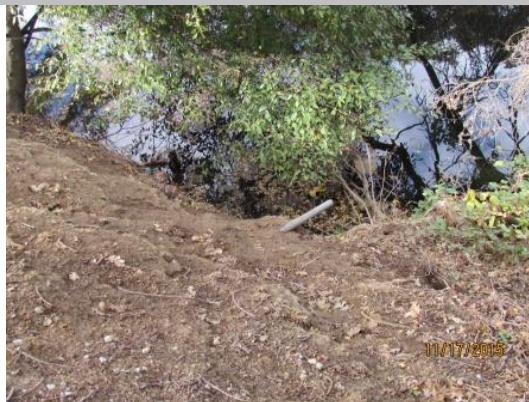
Photo 1 of 1 : SP\_2016\_RD0150\_17\_53\_20160219\_00049.jpg

LM Start	8.02	Rating **	M	Issue No.	53
LM End	8.02	Issue Type +	En	Location *	WS
Category	Earthen Levee			GPS Latitude/Longitude	
				Start	End
Item	Encroachments			38.409145 °	38.409145 °
				-121.539831 °	-121.539831 °
DWR ID	DWR_RD0150_03_f_2015_53				
Comment Code					
PI : Pipe					
Inspector Comment					
An abandon pipe.

View of a pipe on the waterside of the levee.

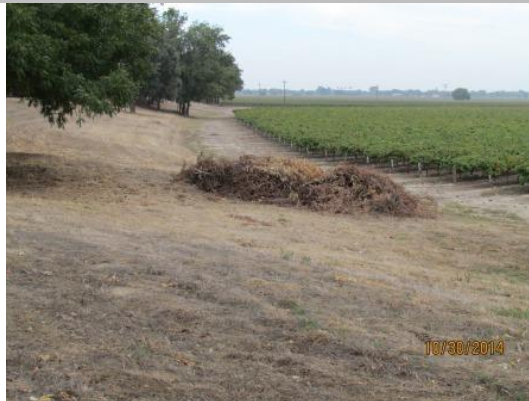
Photo 1 of 1 : SP\_2016\_RD0150\_17\_82\_20160219\_00077.jpg

LM Start	8.05	Rating **	M	Issue No.	82
LM End	8.05	Issue Type +	En	Location *	LS
Category	Earthen Levee			GPS Latitude/Longitude	
				Start	End
Item	Encroachments			38.409224 °	38.409224 °
				-121.539350 °	-121.539350 °
DWR ID	DWR_RD0150_03_f_2013_82				
Comment Code					
PR : Prunings					
Inspector Comment

Prunings were found on the landside toe of the levee looking upstream.

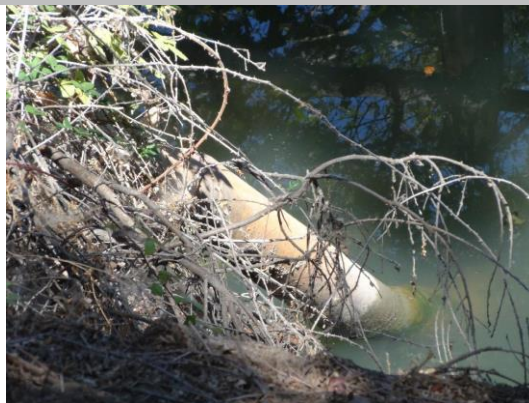
Photo 1 of 2 : UCIP\_SP\_2016\_42688\_33627.jpg

LM Start	8.20	Rating **	U	Issue No.	960
LM End	8.20	Issue Type +	En	Location *	LS
Category	Supplemental			GPS Latitude/Longitude	
				Start	End
Item	DWR UCIP Field Study			38.408619 °	38.408619 °
				-121.536768 °	-121.536768 °
DWR ID					
Comment Code					
Inspector Comment					
FS_ID:42688					
DS_ID:22466					
EP_NO: N/A					
Repair Type: Urgent					
Crossing Status: Found					
UCIP Comments: - needs proper abandonment- pile structure in stream- may need proper abandonment					
FIELD_STRUCT_DESC: 10-inch abandoned steel pipe through the levee, 13.8 feet below the crown. Gate valve on the waterward end.					
Service pole with guy wire on the landward slope. (A. Colby) O&M Manual SAC 112, March 1957.					
FS Date: 8/23/2013

WS view: pipe visible on levee slope and in the stream.

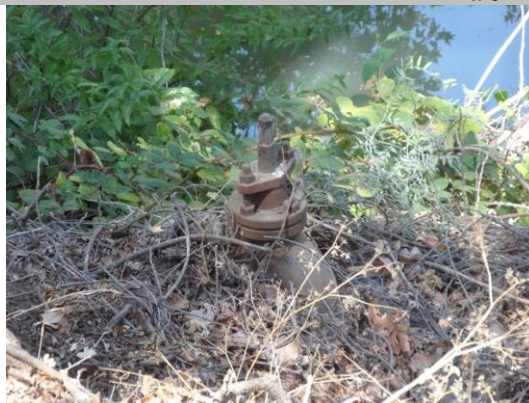
Photo 2 of 2 : UCIP\_SP\_2016\_42688\_33626.jpg

LM Start	8.20	Rating **	U	Issue No.	960 (cont)	
LM End	8.20	Issue Type +	En	Location *	LS	
Category	Supplemental			GPS Latitude/Longitude		
				Start	End	
Item	DWR UCIP Field Study			38.408619 °	38.408619 °	
				-121.536768 °	-121.536768 °	
DWR ID						
Comment Code						
Inspector Comment						
FS_ID:42688						
DS_ID:22466						
EP_NO: N/A						
Repair Type: Urgent						
Crossing Status: Found						
UCIP Comments: - needs proper abandonment- pile structure in stream- may need proper abandonment						
FIELD_STRUCT_DESC: 10-inch abandoned steel pipe through the levee, 13.8 feet below the crown. Gate valve on the waterward end.						
Service pole with guy wire on the landward slope. (A. Colby) O&M						
Manual SAC 112, March 1957.						
FS Date: 8/23/2013

WS view: abandoned gate valve found on levee slope.

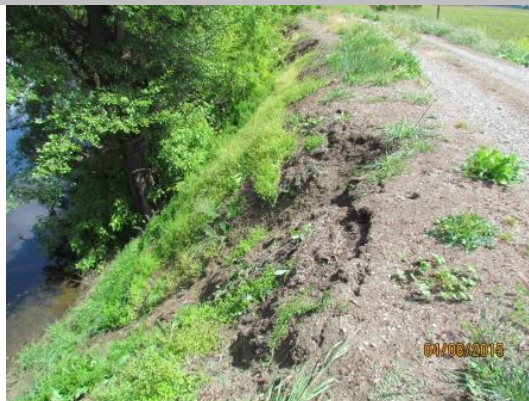
Photo 1 of 1 : SP\_2016\_RD0150\_17\_66\_20160219\_00064.jpg

LM Start	8.31	Rating **	M	Issue No.	66
LM End	8.31	Issue Type +	Ma	Location *	WS
Category	Earthen Levee			GPS Latitude/Longitude	
				Start	End
Item	Erosion / Bank Caving			38.407960 °	38.407960 °
				-121.534898 °	-121.534898 °
DWR ID	DWR_RD0150_03_s_2012_66				
Comment Code					
E1 : Note and monitor erosion site.					
Inspector Comment

Updated picture of the erosion on the waterside of the levee.

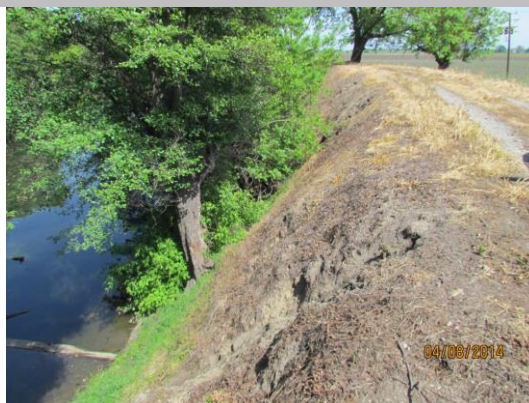
Photo 1 of 2 : SP\_2016\_RD0150\_17\_67\_20160219\_00065.jpg

LM Start	8.33	Rating **	U	Issue No.	67
LM End	8.33	Issue Type +	Ma	Location *	WS
Category	Earthen Levee			GPS Latitude/Longitude	
				Start	End
Item	Erosion / Bank Caving			38.407958 °	38.407958 °
				-121.534583 °	-121.534583 °
DWR ID	DWR_RD0150_03_s_2012_67				
Comment Code					
E1 : Note and monitor erosion site.					
Inspector Comment

Updated picture of the erosion on the waterside shoulder looking upstream during spring 2014 inspection.

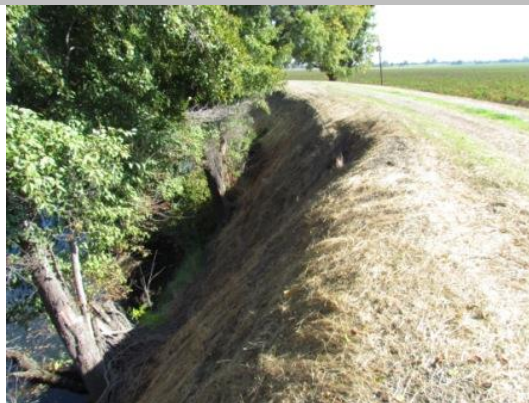
Photo 2 of 2 : SP\_2016\_RD0150\_17\_67\_20160219\_00066.jpg

LM Start	<b>8.33</b>	Rating **	U	Issue No.	<b>67 (cont)</b>
LM End	<b>8.33</b>	Issue Type +	Ma	Location *	WS

Erosion was found on the waterside shoulder of the levee looking upstream. This picture was taken during fall 2012 inspection.

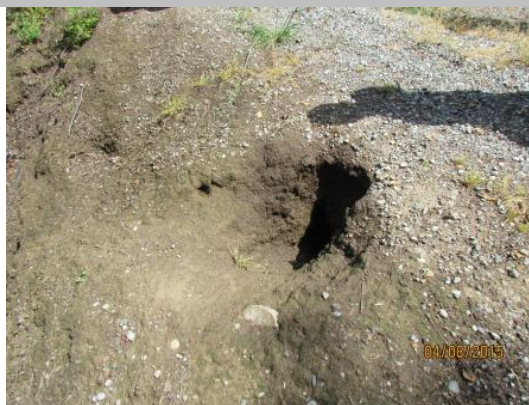
Photo 1 of 2 : SP\_2016\_RD0150\_17\_89\_20160219\_00081.jpg

LM Start	8.37	Rating **	U	Issue No.	89
LM End	8.37	Issue Type +	Ma	Location *	WS
Category	Earthen Levee			GPS Latitude/Longitude	
				Start	End
Item	Animal Control			38.408153 °	38.408153 °
				-121.533980 °	-121.533980 °
DWR ID	DWR_RD0150_03_s_2012_89				
Comment Code					
A1 : Exterminate rodents and backfill and compact or grout burrows.					
Inspector Comment

Updated picture of a rodent hole on the waterside shoulder of the levee during spring 2015 inspection.

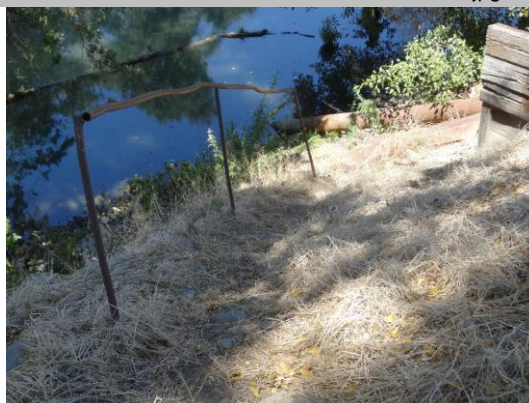
Photo 1 of 2 : UCIP\_SP\_2016\_41648\_33642.jpg

LM Start	8.37	Rating **	M	Issue No.	959
LM End	8.37	Issue Type +	En	Location *	WS
Category	Supplemental			GPS Latitude/Longitude	
				Start	End
Item	DWR UCIP Field Study			38.408188 °	38.408188 °
				-121.533935 °	-121.533935 °
DWR ID					
Comment Code					
Inspector Comment					
FS_ID:41648 DS_ID:22467 EP_NO: N/A Repair Type: Non-Urgent Crossing Status: Found UCIP Comments: - walkway in poor functional condition- an abandoned 8-inch steel pipe next to 12" pipe. This 8" pipe might have merged with 12" pipe under the levee .- Pipe and pump inside concrete masonry wall. FIELD_STRUCT_DESC: 12-inch steel pipe through the levee, 13.0 feet below the crown, pump and gate valve in pump house on the waterward slope. Concrete distribution box at the landward toe. Service pole on the waterward shoulder. O&M Manual SAC 112, March 1957. FS Date: 8/23/2013

WS view: walkway and inlet pipe on levee slope.

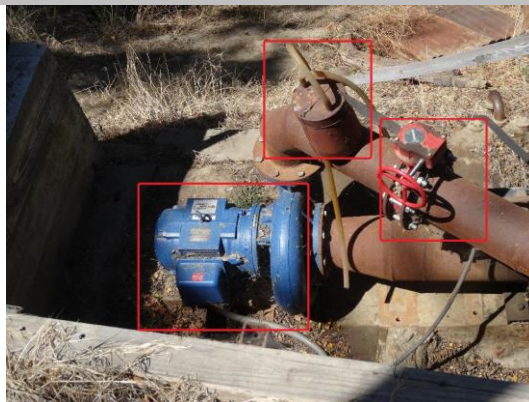
Photo 2 of 2 : UCIP\_SP\_2016\_41648\_33641.jpg

LM Start	<b>8.37</b>	Rating **	M	Issue No.	<b>959 (cont)</b>
LM End	<b>8.37</b>	Issue Type +	En	Location *	WS

WS view: pump, gate valve, and airvent on pipe inside concrete masonry box.

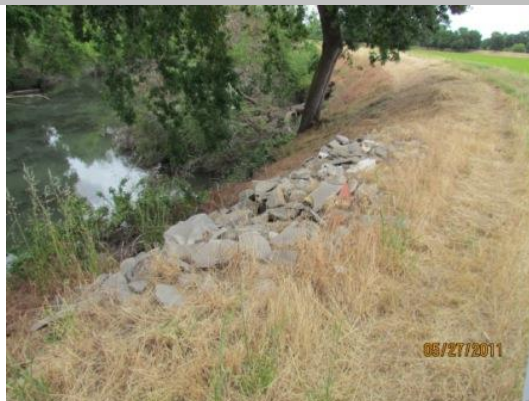
Photo 1 of 1 : SP\_2016\_RD0150\_17\_7\_20160219\_00006.jpg

LM Start	8.72	Rating **	M	Issue No.	7
LM End	8.72	Issue Type +	Ma	Location *	WS
Category	Earthen Levee			GPS Latitude/Longitude	
				Start	End
Item	Encroachments			38.411593 °	38.411593 °
				-121.529143 °	-121.529143 °
DWR ID	DWR_RD0150_03_s_2012_7				
Comment Code					
DE : Debris					
Inspector Comment

Broken concrete pipe was left on the waterside slope of the levee. The picture was taken from the crown looking upstream.

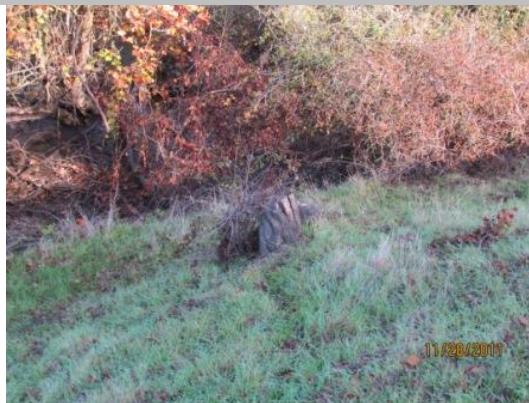
Photo 1 of 1 : SP\_2016\_RD0150\_17\_59\_20160219\_00055.jpg

LM Start	9.21	Rating **	N	Issue No.	59
LM End	9.21	Issue Type +	Ma	Location *	WS
Category	Earthen Levee			GPS Latitude/Longitude	
				Start	End
Item	Trim / Thin Trees			38.413268 °	38.413268 °
				-121.525929 °	-121.525929 °
DWR ID	DWR_RD0150_03_s_2012_59				
Comment Code					
T5 : Tree stumps.					
Inspector Comment

A tree stump was found on the waterside of the levee looking upstream.

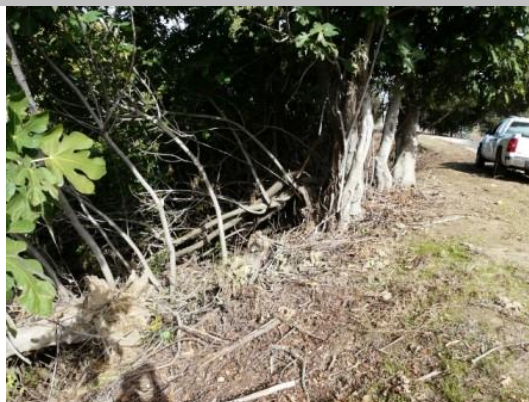
Photo 1 of 1 : SP\_2016\_RD0150\_17\_73\_20160219\_00068.jpg

LM Start	9.35	Rating **	U	Issue No.	73
LM End	9.35	Issue Type +	Ma	Location *	WS
Category	Earthen Levee			GPS Latitude/Longitude	
				Start	End
Item	Trim / Thin Trees			38.413169 °	38.413169 °
				-121.523707 °	-121.523707 °
DWR ID	DWR_RD0150_03_s_2012_73				
Comment Code					
T3 : Trim and thin trees to allow visibility of the ground and room to flood fight.					
Inspector Comment

Thin/trim trees to allow for visibility of top 20' of waterward slope.

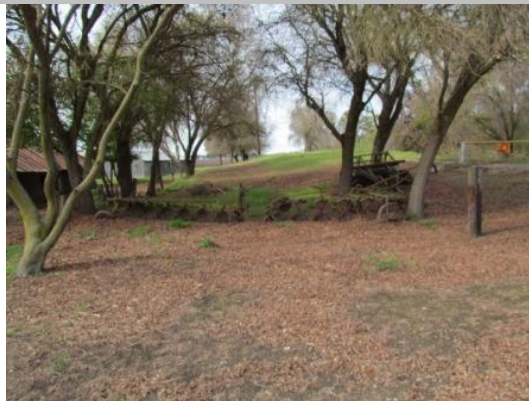
Photo 1 of 1 : SP\_2016\_RD0150\_17\_950\_20160219\_00099.jpg

LM Start	9.39	Rating **	M	Issue No.	950
LM End	9.39	Issue Type +	En	Location *	LS
Category	Earthen Levee			GPS Latitude/Longitude	
				Start	End
Item	Encroachments			38.413560 °	38.413560 °
				-121.522936 °	-121.522936 °
DWR ID	DWR_RD0150_03_s_2012_950				
Comment Code					
EQ : Equipment					
Inspector Comment

Equipment was found on the landside of the levee looking downstream.
